QUANTIFICATION OF QUALITATIVE DEFECTS FOR AUTOMOBILE CUSTOMERS

**Bachelor of Technology
Metallurgical and Materials Engineering Department**

NATIONAL INSTITUTE OF TECHNOLOGY, ROURKELA

May, 2014

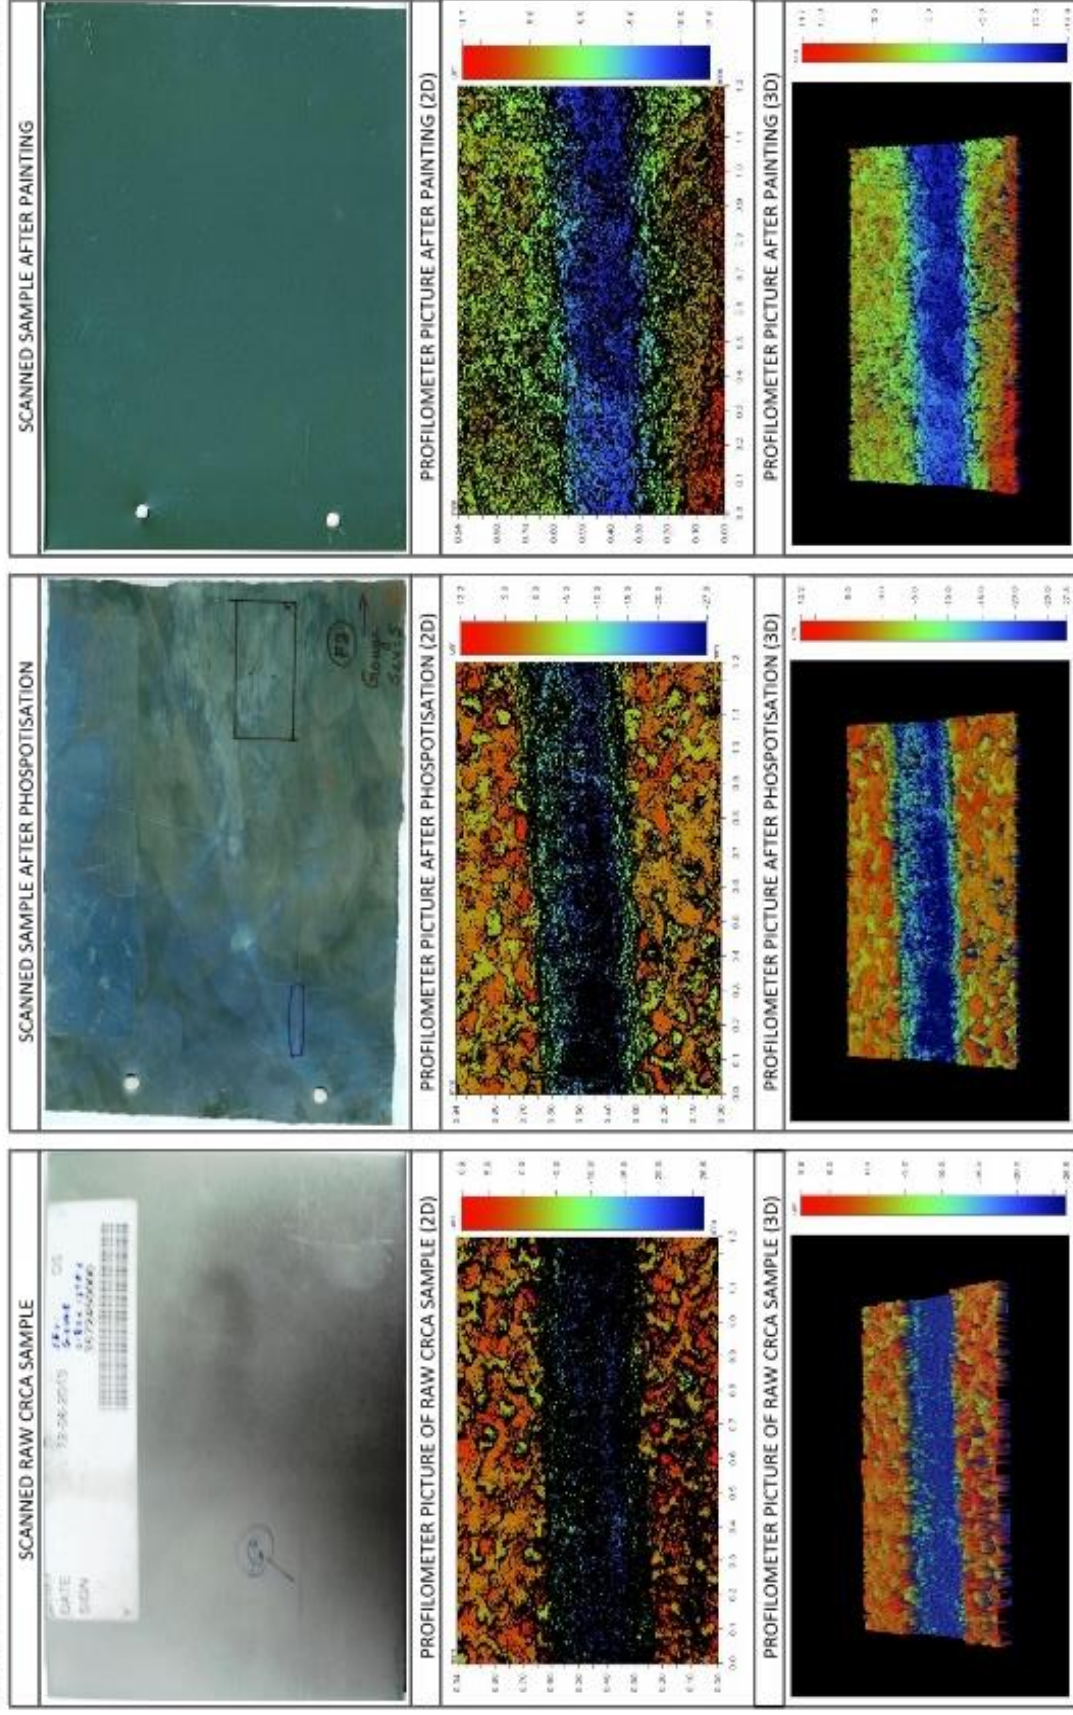
Fig: 5.5.3

COIL ID: 3572451000

DEFECT: GAUGE MARK

SEVERITY: 6

5. Gouge Mark from Severity 4-7 cannot be passed. The difference in total roughness obtained between defected and non-defected area after 1st layer of painting was the order of 8 – 10 μm .
